Service Letter No. 422

SUBJECT: Rework of Propeller Spinner Assembly

MODELS AFFECTED: PA-30 Twin Comanches, Serial Nos. 30-1 to 30-348 inclusive

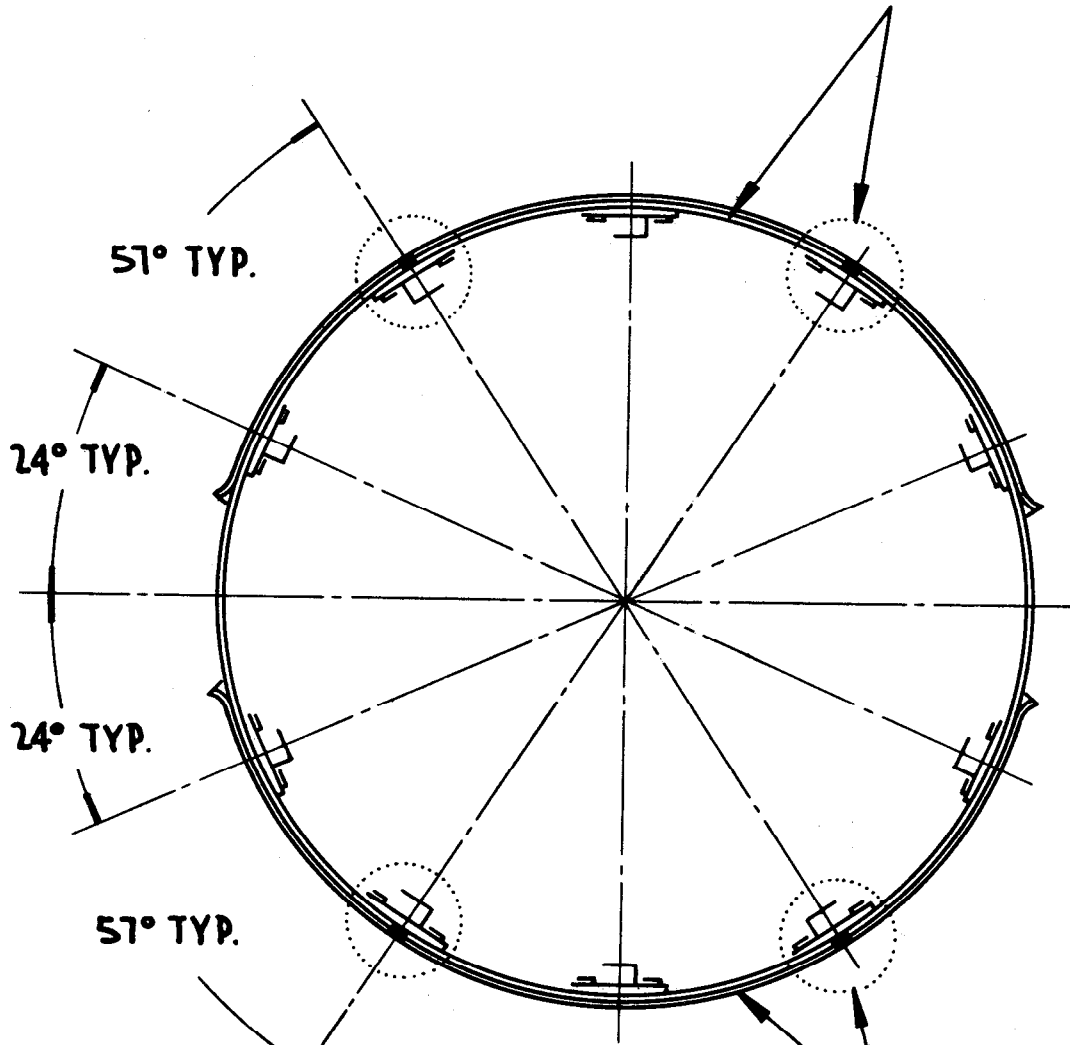
SKETCH A  
KIT 756 796  
Spinner Attachment

We have had reports which indicate that the propeller spinner attaching screws on the subject aircraft are chafing the spinner. In some cases the screw head had chafed sufficiently to wear through the spinner.

In order to correct this situation we have added four (4) additional screws to each spinner. These screws are installed midway between existing screws. Refer to sketch on the reverse side of this service letter.

.189/.191 HOLE (4 REQ.)  
ANCHOR NUT NAS686A3 (4 REQ.)  
RIVET AN426AD3-4 (8 REQ.)  
(ADD TO 23815 BULKHEAD ASSY.)

.189/.191 HOLE (4 REQ.)  
(ADD TO 23818 SPINNER ASSY.)

SCR. AN526-1032D8 (4 REQ.)  
(AT INST.)
